**Center for Climate Crime Analysis
Report to the Council on Ethics
of the Norwegian Government Pension Fund Global
on the situation in Cerro de Pasco**

28 June 2019

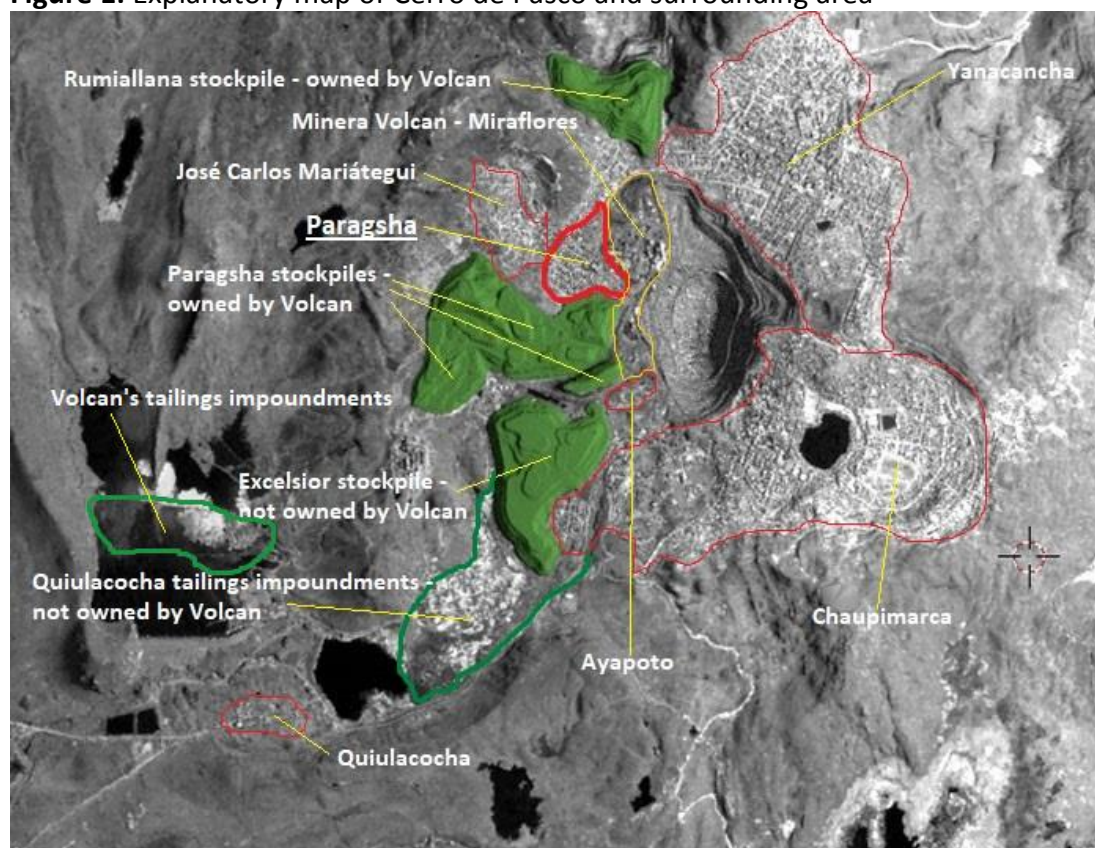
Figure 1: Explanatory map of Cerro de Pasco and surrounding area

37. The Rumiallana and Paragsha stockpiles (Figure 1) are a principal source of pollution for soil and water in Paragsha and other areas of Cerro de Pasco located in close vicinity to these stockpiles. Heavy metals are not biodegradable; they persistently remain in the environment.⁶¹ Soil samples taken by Source International in February 2019 from the

72. Similarly, the pollution of the Tingo River can significantly be attributed to Volcan's mining activities, and in particular to Volcan discharging of waste rock at the Rumiallana stockpile, which is located above the source of the Tingo River (Figures 1 and 7). In early 2009, Source International measured the water quality at the source of the Tingo River and found that it vastly exceeded WHO water quality standards for many heavy metals, such as lead, arsenic, cadmium, copper and zinc.¹⁴² In September 2016, when Volcan's mining activity in Cerro de Pasco was temporarily suspended, Source International again measured the water quality at the source of the Tingo River. It found that all values had significantly improved compared to 2009. The levels of arsenic, cadmium, copper and zinc were within maximum permissible levels, while the level of lead—although significantly improved—still exceeded water quality standards¹⁴³ by a large margin.¹⁴⁴ This again demonstrates a direct link between Volcan's operation of the mine and the contamination of the water of the Tingo River.

generally carried in the same direction, namely from the Excelsior stockpile, which lies to the south-west of Cerro de Pasco to south-western direction and away from the city (see also Figure 1).

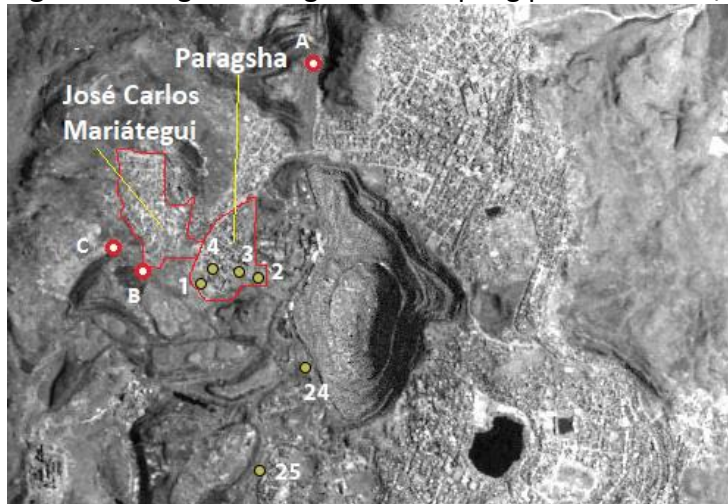
Figure 4: image locating some sampling points of 2013/2019 soil studies

1 Children playground (Pb: 5.368; As: 1.263; Cd: 15; Hg: 39); 2 football field (Pb: 3.792; As: 765; Cd: 25); 3 interior courtyard of primary school (Pb: 3.785; As: 1.065; Cd: 15); 4 children playground (Pb: 6.000; As: 1.245; Cd: 21; Hg: 40); 24 road immediately next to open pit (Pb: 2.011; As: 199; Cd: 11); 25 road next to Excelsior stockpile (Pb: 3.251; As: 457; Cd: 20); A Rumiailana stockpile (Pb: 18.000; As: 76); B Paragsha stockpile (Pb: 18.000; As: 1.600); C Paragsha stockpile (Pb: 7.300; As: 1.100).

Rumiallana and Paragsha stockpiles show extremely high metal concentrations.⁶² For instance, the lead levels were between 7.300 and 18.000 mg/kg. Similarly, the arsenic levels were between 760 and 1.100 mg/kg.⁶³ The levels of iron, zinc, copper and manganese were also found to be extremely high.⁶⁴ During the rainy season, rainwater flowing off the stockpiles can contain high heavy metal concentrations and pollute areas in close proximity to the stockpiles through a process called acid rock drainage. On the basis of these three soil samples, Source International estimated the acid production potential of the Rumiallana and Paragsha stockpiles by applying the recognized EPA Method.⁶⁵ It concluded that for all three soil samples the acid production potential is extremely high, namely between 82,3 and 425.⁶⁶ This is corroborated by a previous study conducted by four Swiss and German scientific institutions published in 2006. That study examined the acid rock drainage of the Excelsior stockpile (Figure 1). The study found that Excelsior produced acid rock drainage rich in iron, manganese, copper, zinc, cadmium, arsenic and sulphur.⁶⁷ Given the similar chemical composition of the Rumiallana and Paragsha stockpiles—storing waste rock from the same mine⁶⁸—it can be inferred that the acid rock drainage effects of those stockpiles are similar to those of Excelsior.

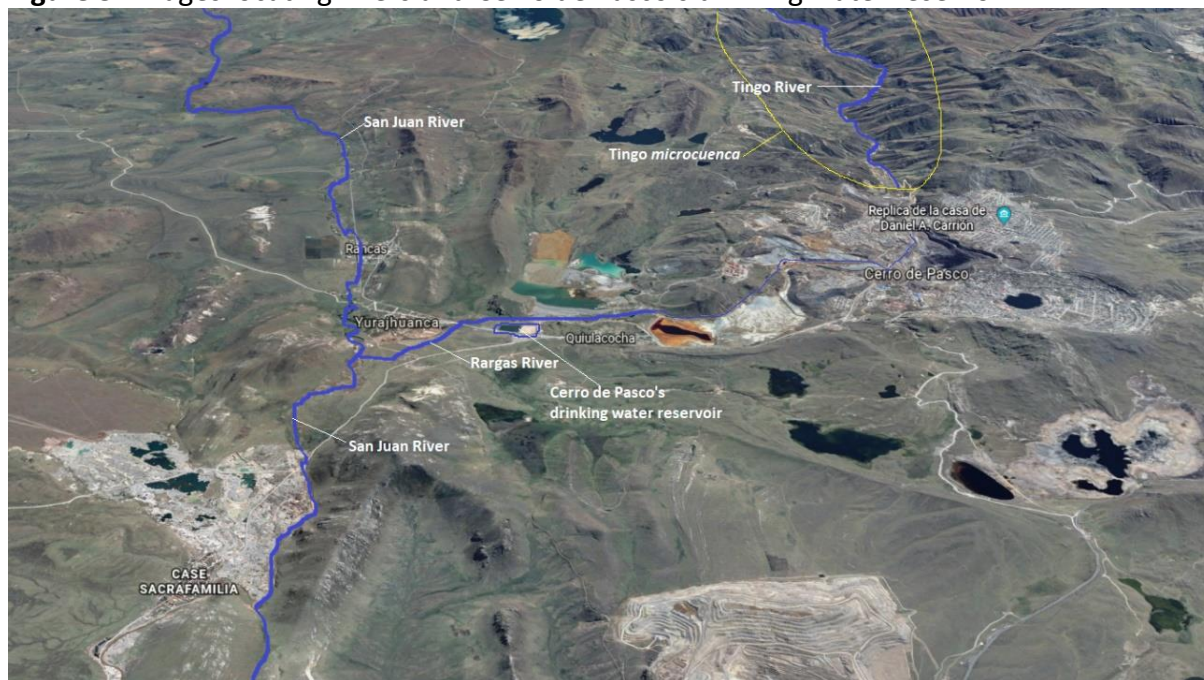
Figure 5: images locating rivers and Cerro de Pasco's drinking water reservoir

42. The Tingo River flows from the northern part of Cerro de Pasco in a northerly direction. Its source emerges from water tubes that come out from underneath the Rumiallana stockpile, which Volcan uses as its waste rock dump site. In 2009, Source International measured the water quality at the source of the Tingo River and found that it vastly exceeded applicable water quality standards for many heavy metals, such as lead, arsenic, cadmium, copper and zinc.⁷⁸

75. The drinking water reservoir for Paragsha and some other parts of Cerro de Pasco is located to the west of Quiulacocha and immediately below the highly contaminated Ragra River (Figure 5). A comparison between the 2009 and 2016 studies on drinking water further leads to the conclusion that the contamination of drinking water can be attributed to Volcan's mining activities. As noted above, in 2009, Source International examined the drinking water in Paragsha; it found that this water exceeded the WHO drinking water standards for lead and arsenic by about four times, for aluminum by about two times and for tin by about thirteen times.¹⁴⁷ These results are consistent with the findings of the local health authorities in 2007, 2009 and 2015.¹⁴⁸ In September 2016—at a time when Volcan's mining activities in Cerro de Pasco were suspended¹⁴⁹—Source International again tested the drinking water in Paragsha and in Chaupimarca (Figure 7). All measurements for the 12 tested heavy metals were within water quality standards for drinking water.¹⁵⁰ This demonstrates a causal link between the mine's operations and the contamination of Cerro de Pasco's drinking water.

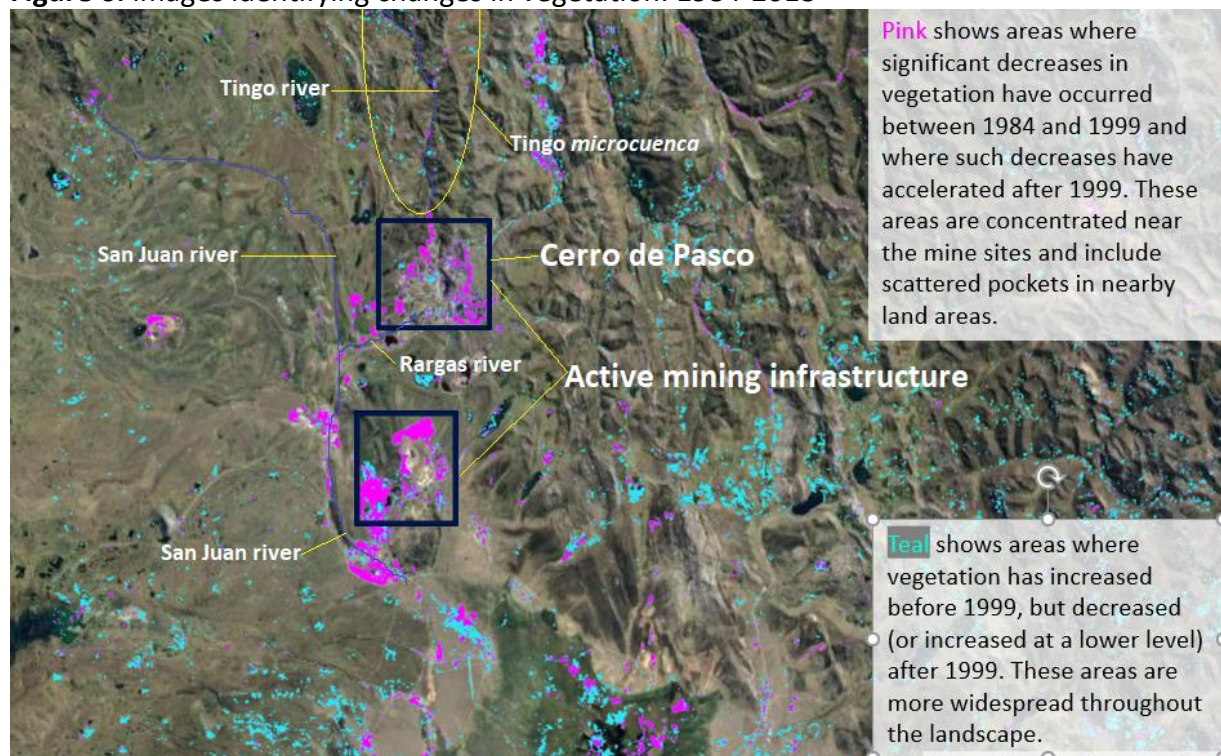
Figure 6: images identifying changes in vegetation: 1984-2018

45. Contaminated water runoff and dust related to mining can impact on agricultural and other vegetation and therefore enter into the human food chain. Nicholas Cuba from Clark University measured the change of vegetation around Cerro de Pasco from 1984 until 2018. He used the Normalized Difference Vegetation Index (NVDI), which approximates how “green” or photosynthetically productive vegetation is during an annual period. The study concluded that there were significant decreases adjacent to, downstream from, and near Cerro de Pasco. These decreases have accelerated after 1999,⁸⁵ when Volcan acquired the mine.

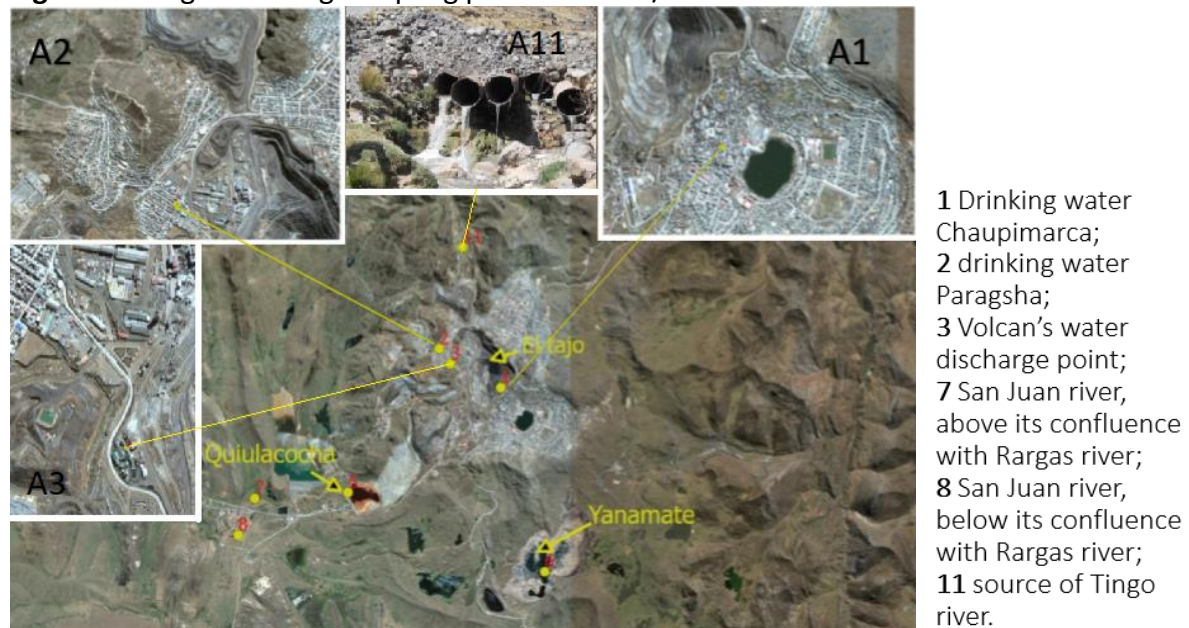
Figure 7: images locating sampling points of 2009/2016 water studies

47. The drinking water for Paragsha and some other parts of Cerro de Pasco derives from a reservoir which is located between Quiulacocha and Yurajhuanca, immediately below the Ragra River (Figure 5). From there the water is piped and distributed to various neighbourhoods of Cerro de Pasco, including Paragsha. The competent regional health authorities (DIRESA) found that in March 2007 and in 2009 the drinking water of Cerro de Pasco's districts of Quiulacocha and Chaupimarca contained lead above the limits recommended by WHO.⁸⁶ WHO's recommended lead limit is identical to the Peruvian limit established in 2008⁸⁷ and 2010,⁸⁸ namely 0,01 mg/l. Source International examined drinking water in Paragsha in 2009, and found that it drastically exceeded the applicable water quality standards for numerous heavy metals. For instance, it contained 0,039 mg/l of lead and 0,043 mg/l of arsenic (for which the upper limit is also 0,01 mg/l).⁸⁹ After Volcan was given the licence to provide drinking water to Cerro de Pasco in 2011,⁹⁰ Cerro de Pasco's drinking water continued to be contaminated. Testing conducted by the Ministry of Health in late November 2015 showed that the drinking water in 13 locations in Cerro de Pasco's districts of Simón Bolívar (which includes Paragsha), Chaupimarca and Yanacancha exceeded the maximum permissible levels of lead, arsenic, aluminium and iron.⁹¹

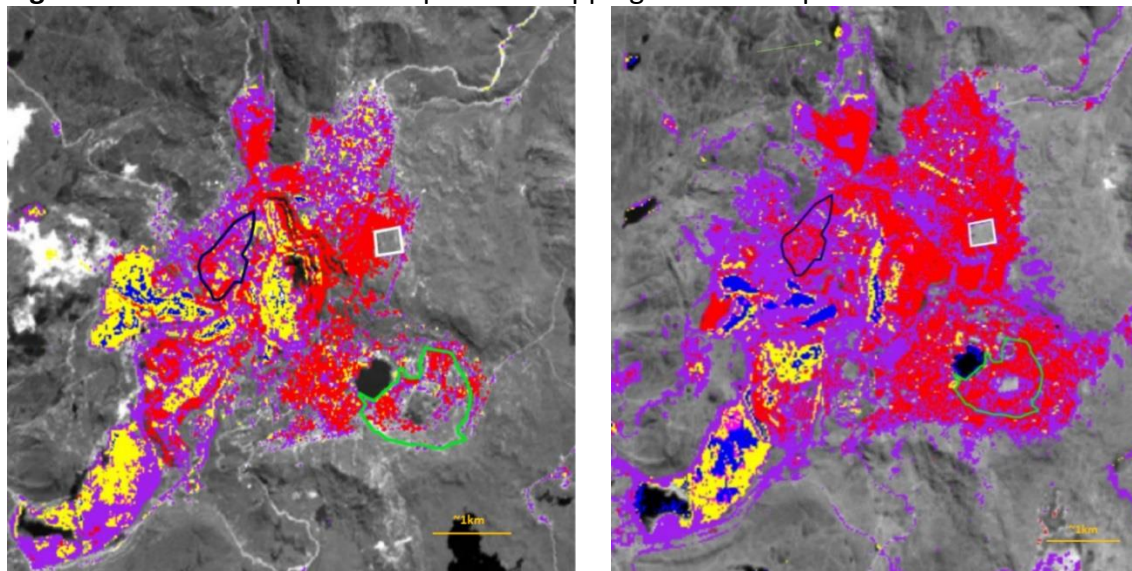
Figure 8: reflectance spectroscopic lead mapping in mineral species in Cerro de Pasco

57. According to the study, it is likely that the redistribution and increase in lead bearing mineral species detection during the 2001-2018 period is primarily anthropogenic in nature and related to mining (i.e., material removing, tailing dumping, human foot print and automobile traffic). This conclusion is supported by a visible increase in lead bearing minerals spectra that can be observed along highways and roads not only in the city of Cerro de Pasco, but along roadways throughout the entire region. To a lesser extent, the expansion of lead bearing minerals may be attributed to meteorological phenomena, such as wind and rain.

ASTER image from 2001 of Cerro de Pasco

Sentinel2 image from 2018 of Cerro de Pasco

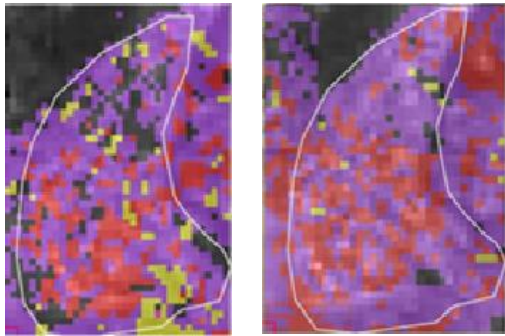
Figure 9: reflectance spectroscopic lead mapping in mineral species in Paragsha

2001 ASTER and 2018 Sentinel 2 images of Paragsha

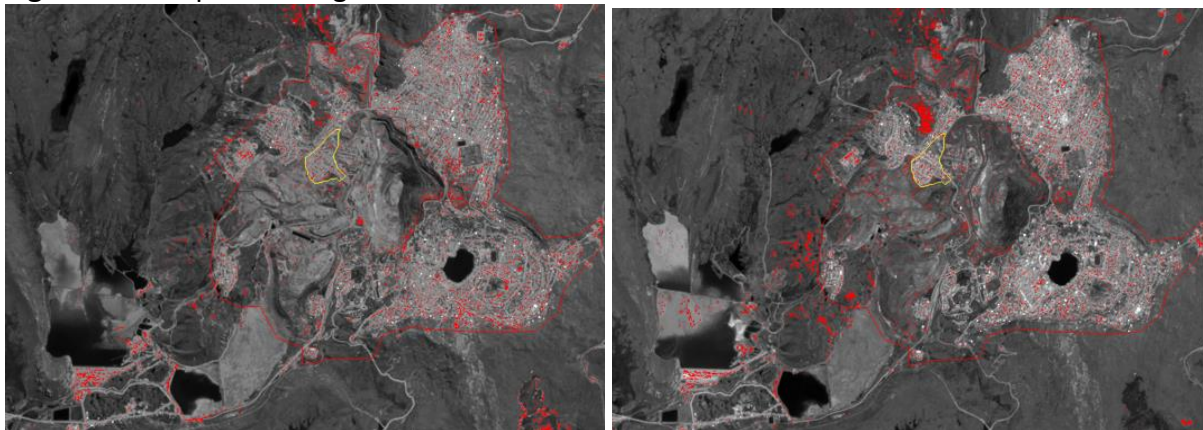
Figure 10: temporal change in PbSo4 areal cover in Cerro de Pasco: 2016-2018

58. A separate remote sensing study conducted by CybELE further demonstrates that an increase of lead pollution in the soil of Cerro de Pasco (Figure 10), and in particular in Paragsha (Figure 11), can also be observed for the more recent period. It compared spectral indexes of two Sentinel 2 images, focussing on anglesite (PbSo4). The first image was taken on 26 April 2016, the second one on 27 November 2018—one year after Glencore acquired the majority of Volcan’s voting shares. The study concluded that in the area of Paragsha alone, there was an overall increase of 2.700² in the area covered with anglesite (despite some confined areas where the contamination decreased). Significant further increases during this time period can also be observed in the immediate vicinity of Paragsha.¹¹²

PbSo4 conditions 2016 (red)

PbSo4_conditions 2018 (red)

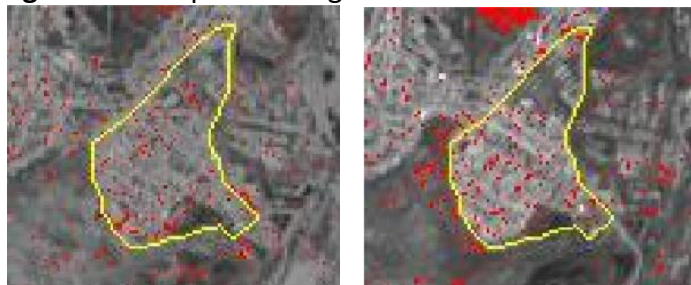
Figure 11: temporal change in PbSo4 areal cover in Paragsha: 2016-2018

PbSo4 conditions 2016 (red)

PbSo4_conditions 2018 (red)
